RACINE CREAM BRICK STRUCTURES: An Inventory

Prepared by: Matthew G. Sadowski, Candidate, MS-Architecture

For the course: ARCH 792-001 (45760) Independent Studies & Research

Date of submission: May 16, 2023. Revised June 20, 2023.

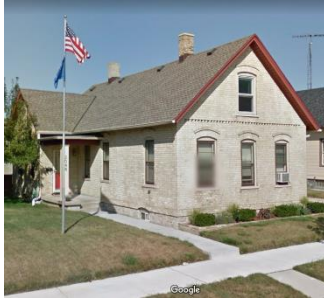
Original: structure appears to be presenting as originally constructed (2048 N. Wisconsin St. ca 1893). Of this type, 253 structures were noted. These structures display no apparent exterior additions or alterations that depart from the original configuration of the structure when first constructed. The brick on these structures displays no apparent evidence of having ever been painted.

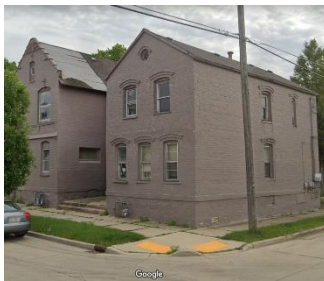
Original, Painted: structure appears to be original, but brick has been painted (1840 N. Wisconsin St. ca 1900). Of this type, 44 structures were noted. These structures display no apparent exterior additions or alteration that depart from the original configuration of the structure when first constructed, but the cream brick has been painted (peeling paint helped to identify the cream brick beneath).

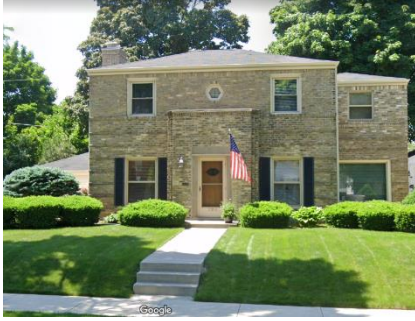
Original, Reclaimed: entire structure built with reclaimed cream brick (722 Orchard St. ca 1941). Of this type, 135 structures were noted. These structures display no evidence of the brick being painted, but their later construction and brick appearance indicated that the structure was built from salvaged cream brick: bricks have varying tones of cream, tan, green, or red hues, or assorted brick show evidence of original environmental staining, or painting. The structures may have

additions which post-date the original date of construction.

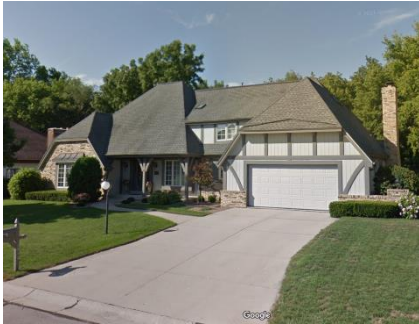
Reclaimed, Accents: structure displays reclaimed cream brick as a decorative accent (single façade, wainscotting, porch, store front, etc.) (3737 Canada Goose Crossing ca 1992). Of this type, 42 structures were noted.
